Machinery Messages

Using ADRE® 3 to on a pressurized water

*By Marc Tompkins
Branch Manager
Bently Nevada Corporation
Pittsburgh, Pennsylvania*

diagnose problems on reactor coolant pump

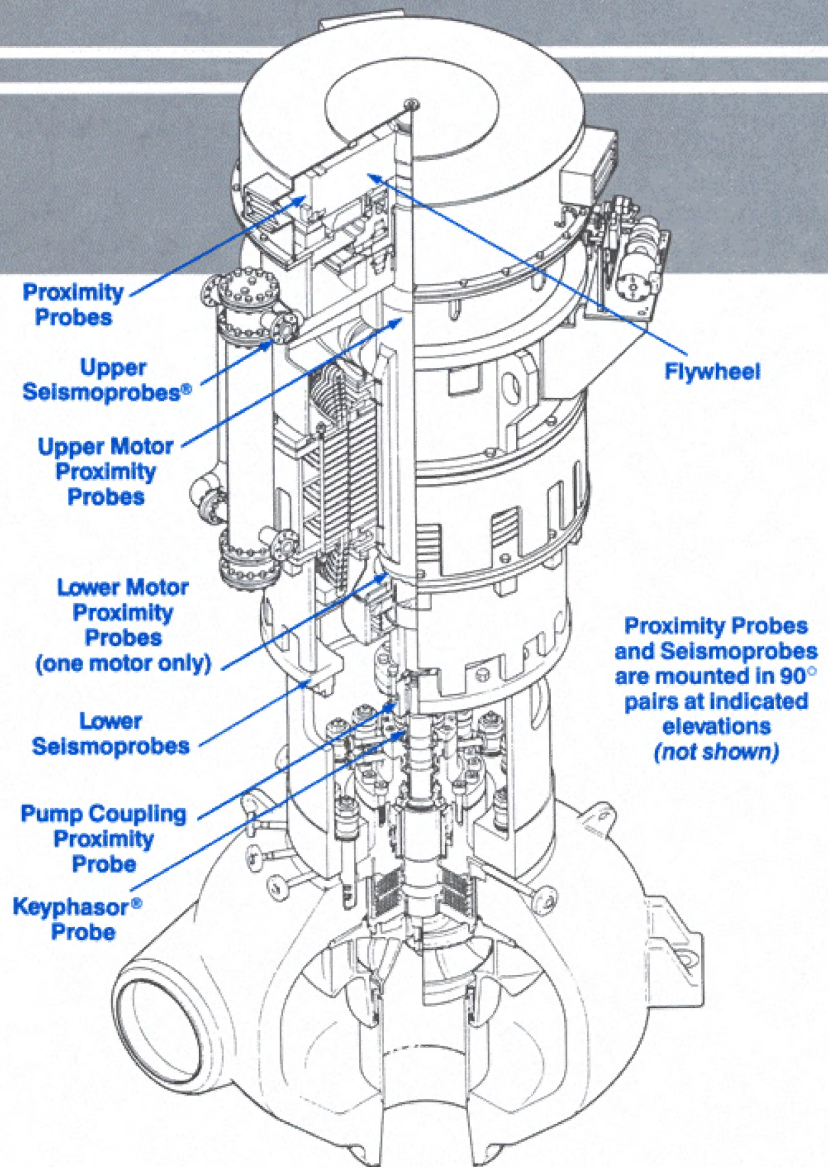
Figure 1
Diagram of a reactor coolant pump

The reactor coolant pump is a vertically oriented machine which circulates primary coolant from the pressurized water nuclear reactor through a steam generator. It is a centrifugal pump driven by a 1480 rpm, 7000 HP motor. The pump circulates approximately 94,000 gallons per minute (gpm) of coolant at 550°F (288°C) and 300 ft. (100 m) of head. The motor and pump are rigidly coupled since the entire machine has only three radial bearings (two oil lubricated, pivoted-pad motor bearings and a large water-lubricated plain journal bearing, L/D = 1). The pump bearing is maintained at a low temperature, relative to the pumped fluid, by the injection of cool water into the seal/bearing area and by the thermal barrier heat exchanger just below the bearing assembly. Coolant enters the machine from the bottom of the casing and exits through a tangential discharge. The hydraulics are designed to provide a 2000-3000 lb (907 to 1361 kg) radial side load (depending upon water temperature) on the impeller to provide a static load on the radial bearings. Figure 1 illustrates the machine arrangement.

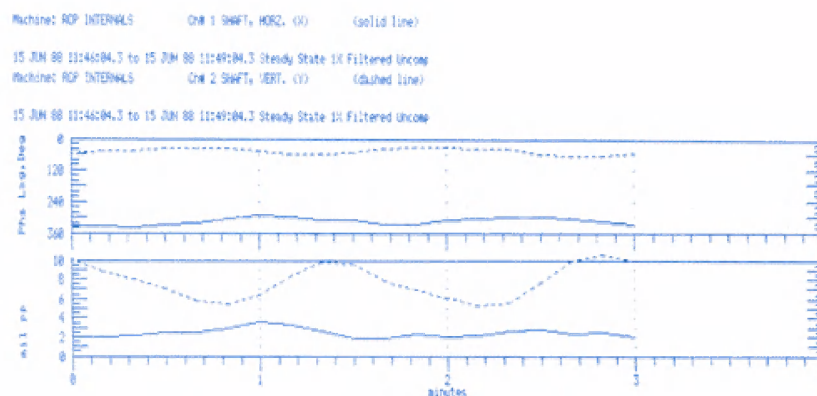
Figure 2

With the 108 DAI, Stan obtained steady state data at plant full power conditions. Using ADRE®3 Software, he plotted Bodé, Shaft Centerline and Spectrum plots. From data obtained via the proximity probes, the (APHT) Amplitude & Phase versus Time plots generated (Figure 2) revealed vibration cycling with relatively minor changes in phase angle. The Spectrum plots (Waterfall format,

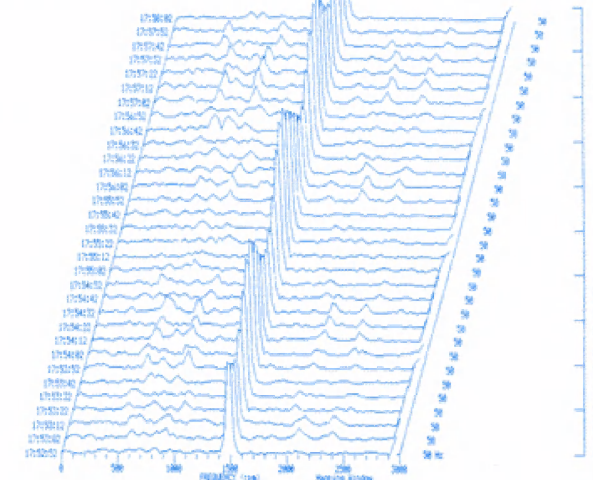
Figure 6

Figure 6) also illustrated the vibration cycling, the presence of submultiple components and multiple components above running speed, but only at certain times during each cycle's period.

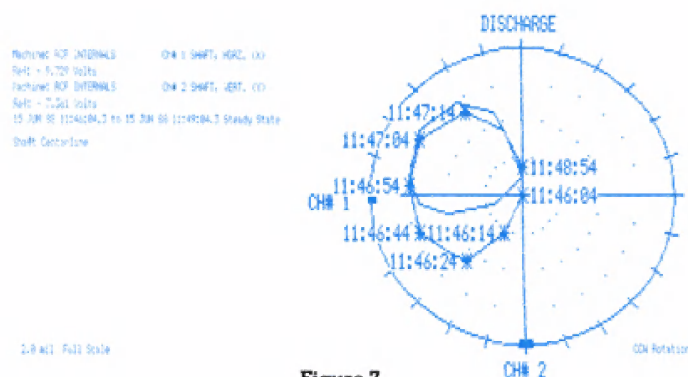
Figure 7

Other plots were more revealing. At steady state conditions, the Shaft Centerline plot (Figure 7) indicated that the shaft was moving radially within the bearing clearance. More importantly, it indicated the variation occurred in a clockwise precession, opposite to the rotational direction of the pump shaft. Seismic transducers mounted on the motor frame revealed little additional information on the nature of the problem.

After seeing the reverse precession direction of the shaft centerline, Stan suspected a rub condition. The unusual pattern of submultiples had hinted that rubbing was a possibility. However, lack of Keyphasor signal jitter and the slow changes in the vibration levels did not fit the traditional ideas of what a rub usually looks like (though they didn't contradict the notion that a rub could still be present). Stan likened this motion to a "lubricated dry rub". A full dry rub produces backwards precession at much higher speed (and usually quickly destroys the machine). This motion is primarily forward spin of the rotor with a small component of torsional drag due to rubbing causing the rotor to precess

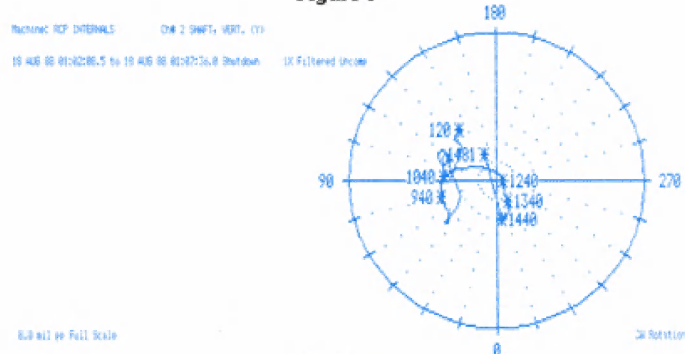
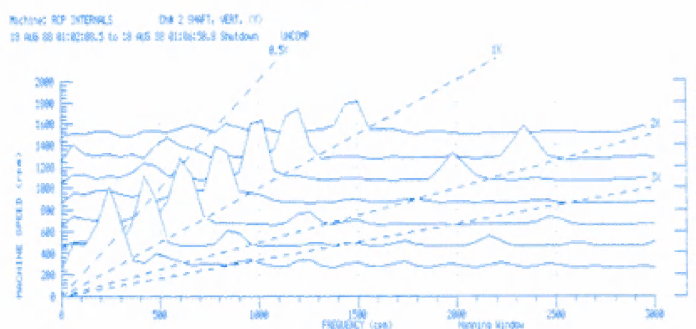
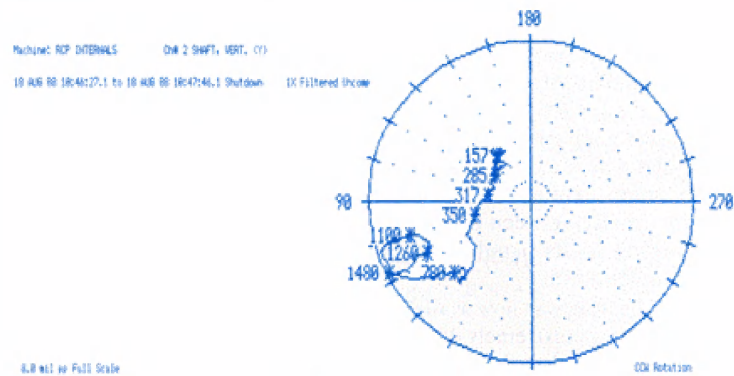
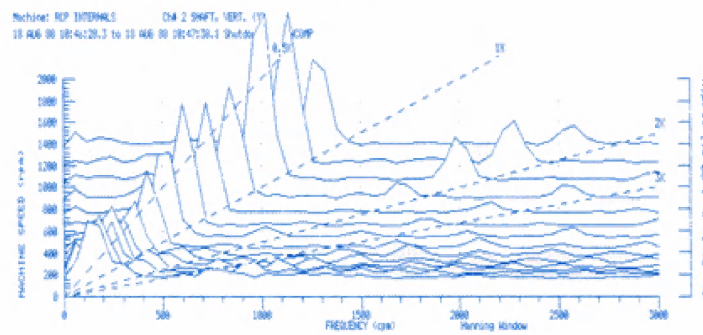
New information obtained affirmed the rub hypothesis and confirmed the explanations which related the oscillating seal flows and cycling vibration to the oscillations in shaft centerline position. Figures 9, 10, 11 and 12 show two coastdowns taken by the ADRE®3 equipment in the normal course of data acquisition which appear to have come from two very different machines. Correlation of these plots with the shaft centerline plots (not shown) proved that these two coastdowns were initiated when the shaft centerline positions were almost as far apart as they could be. Vibration amplitudes were also near the extremes of their ranges. Given this data, it was more certain that the variation in dynamic bearing constants was responsible for the oscillation in the amplitude of vibration.
